**Flood Control Project Maintenance
Levee Inspections**

Fall 2012 Levee Maintenance Deficiency Summary Report

San Joaquin River Basin

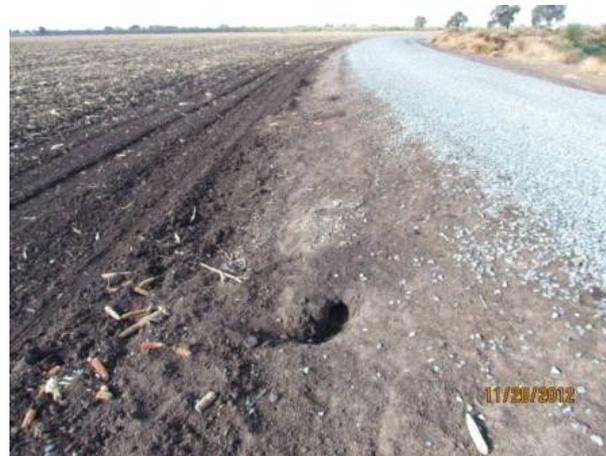
Levee Mile Report Line	3
Start Levee Mile	0.30
End Levee Mile	0.30
Location	Water Side
Category	Earthen Levee
Item	Animal Control

Animal holes were found on the waterside of the levee looking upstream.

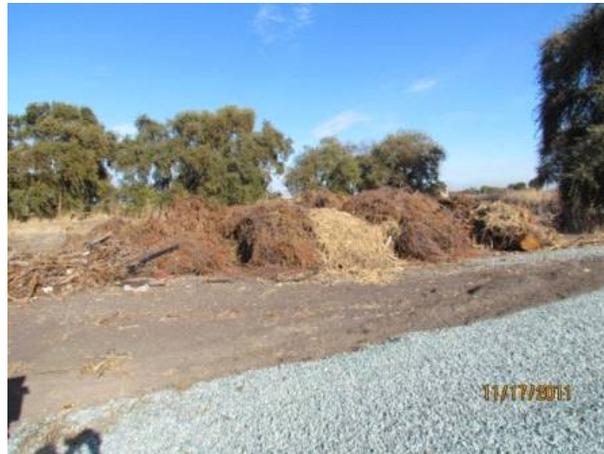
Levee Mile Report Line	11
Start Levee Mile	1.32
End Levee Mile	1.32
Location	Water Side
Category	Earthen Levee
Item	Encroachments
Prunings were found on the waterside of the levee looking upstream.	
pkazi_f_20120913_009.jpg

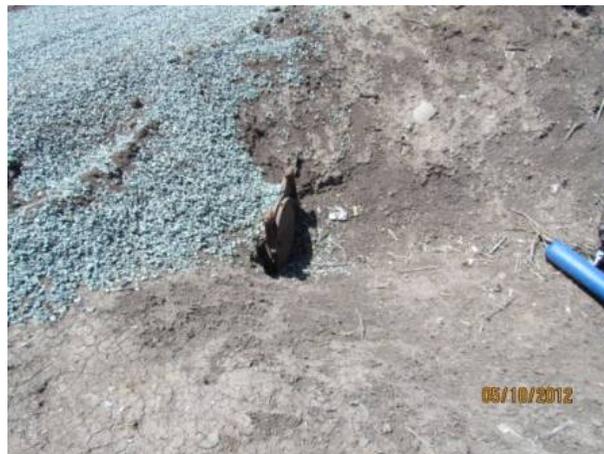
Levee Mile Report Line	12
Start Levee Mile	1.43
End Levee Mile	1.43
Location	Water Side
Category	Interior Drainage & Piping Systems
Item	Flap Gates
The flap gate is fixed by the LMA on the waterside of the levee looking downstream.	
pkazi_f_20120913_008.jpg

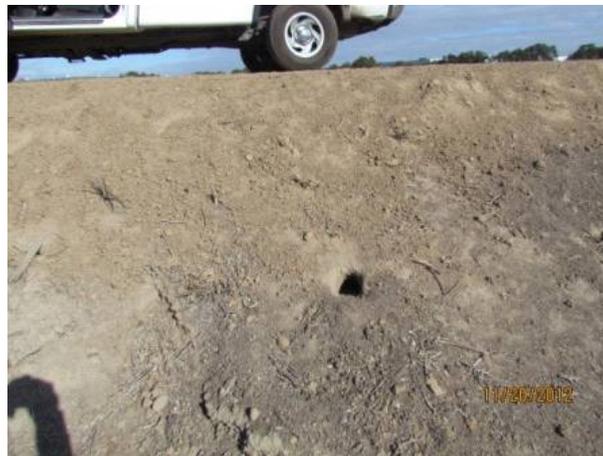
Existing erosion was repaired by the LMA on the waterside slope of the levee looking downstream.

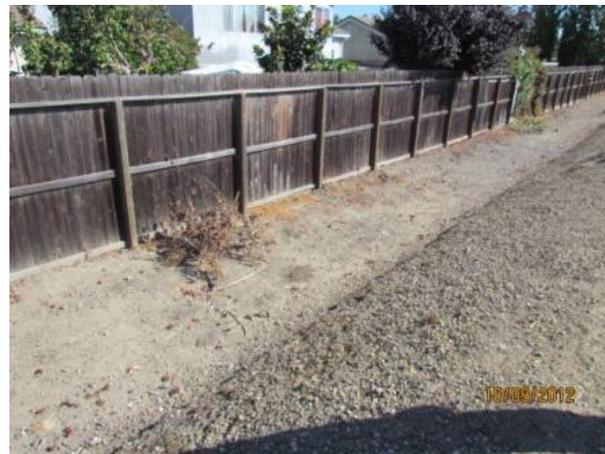
Levee Mile Report Line	11
Start Levee Mile	2.66
End Levee Mile	3.17
Location	Land Side
Category	Earthen Levee
Item	Encroachments

A ditch was found on the landside of the levee looking downstream.

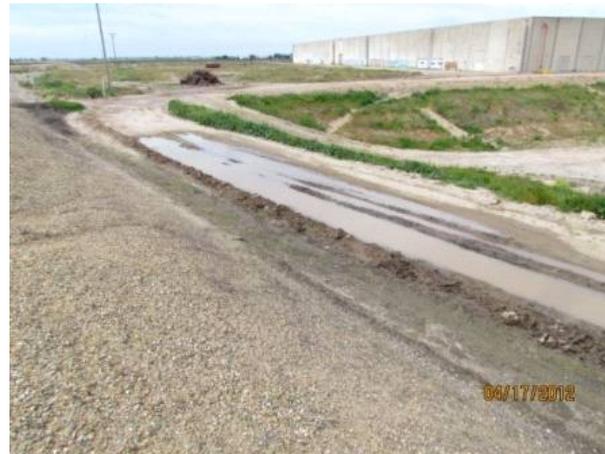
Levee Mile Report Line	53
Start Levee Mile	6.06
End Levee Mile	6.16
Location	Land Side
Category	Earthen Levee
Item	Slope Stability
Ponded water was found on the toe of landside of the levee looking downstream.	
pkazi_f_20120913_040.jpg

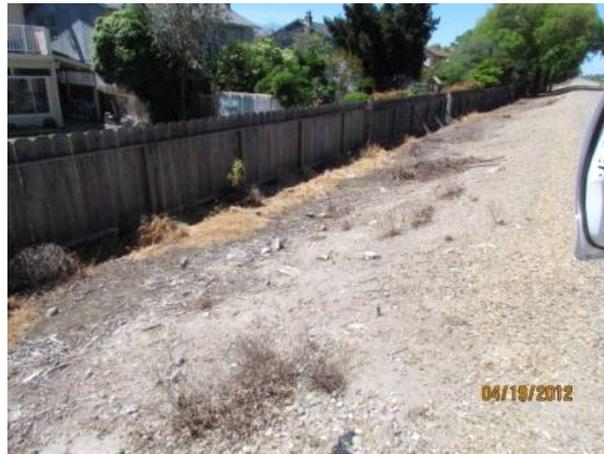
Levee Mile Report Line	79
Start Levee Mile	2.69
End Levee Mile	2.69
Location	Land Side
Category	Earthen Levee
Item	Encroachments
Debris was found on the landside of the levee looking downstream.	
pkazi_f_20120913_121.jpg

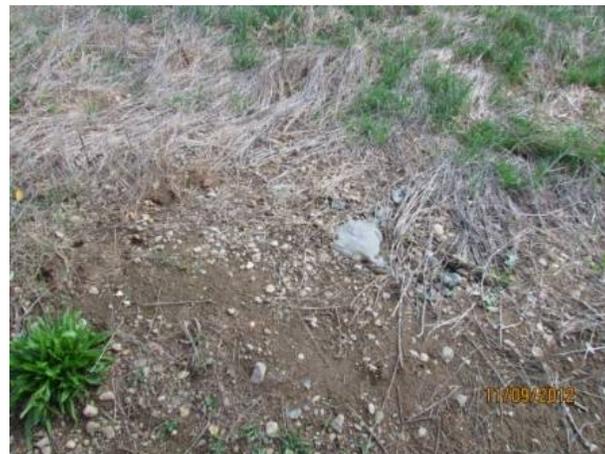
Levee Mile Report Line	149
Start Levee Mile	15.42
End Levee Mile	15.42
Location	Land Side
Category	Earthen Levee
Item	Animal Control
Animal hole was grouted by the LMA on the landside of the levee looking upstream.	
pkazi_f_20121109_047.jpg

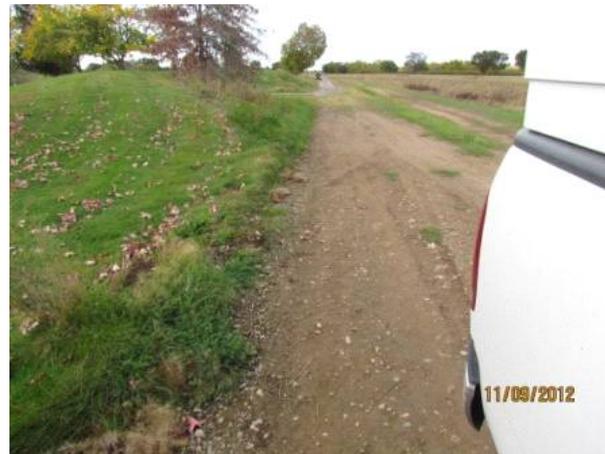
Levee Mile Report Line	156
Start Levee Mile	16.12
End Levee Mile	16.12
Location	Crown
Category	Earthen Levee
Item	Crown Surface / Depressions / Rutting
Crown depression was repaired by the LMA looking downstream.	
pkazi_f_20121109_049.jpg

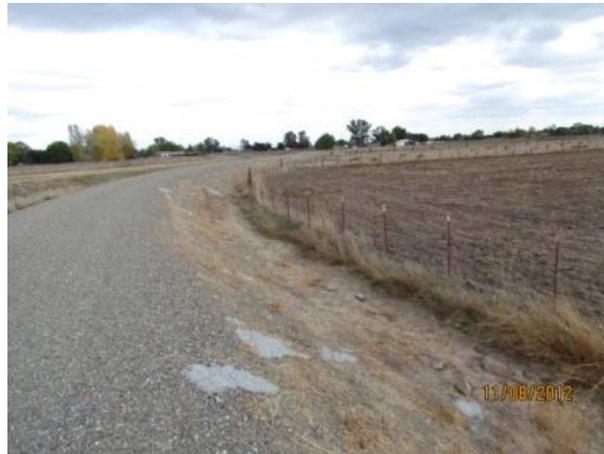
Levee Mile Report Line	3
Start Levee Mile	1.20
End Levee Mile	1.44
Location	Land Side
Category	Earthen Levee
Item	Encroachments
Fence was found on the landside toe of the levee looking upstream.	
pkazi_f_20121109_033.jpg

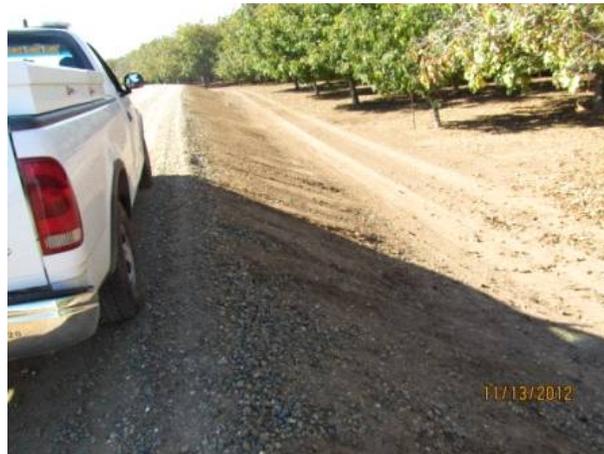
Levee Mile Report Line	33
Start Levee Mile	3.00
End Levee Mile	3.00
Location	Land Side
Category	Earthen Levee
Item	Slope Stability
<p>The LMA has fixed several slope instability issues on the landside slope of the levee looking downstream.</p>	
<p>pkazi_f_20121114_055.jpg</p>
